PROPERTY VISIT

For the premises
58 Holgate Rd, London DG7 7WP

Taken on
9th December, 2020

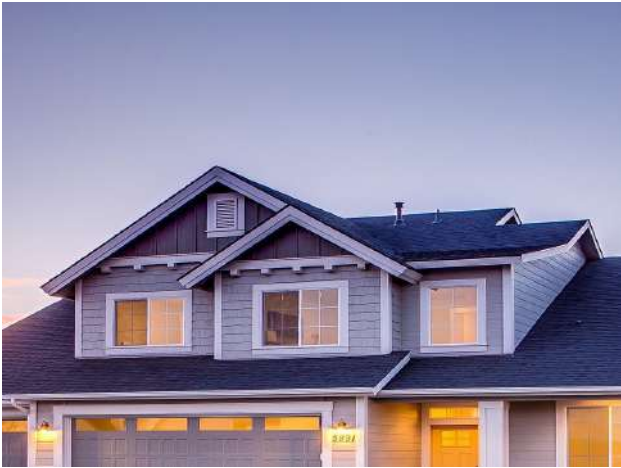
Roof

Good Order

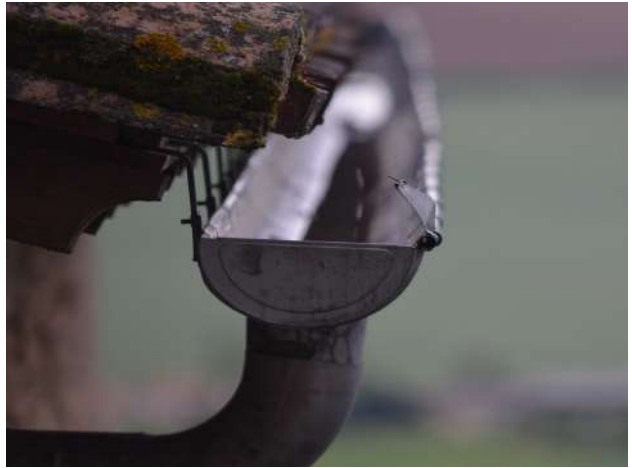
Gutters / Pipes

Good Order

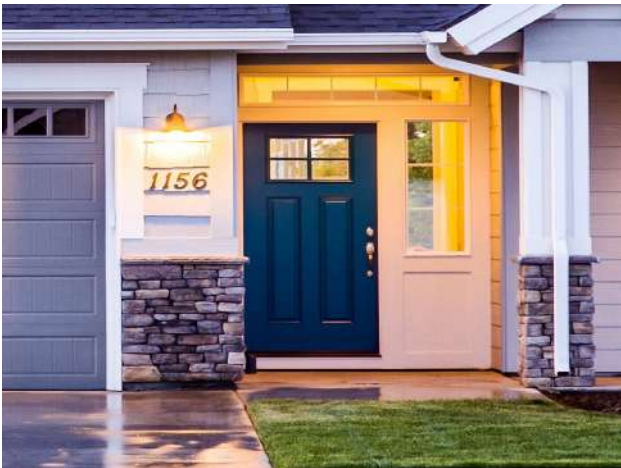
Exterior Decor

Good Order

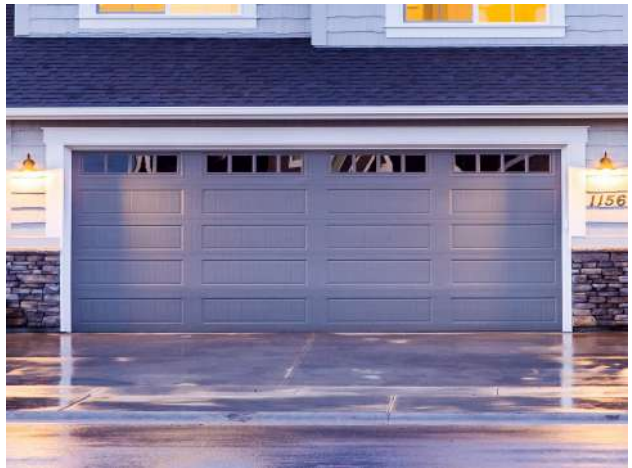
Drive / Paths

Good Order

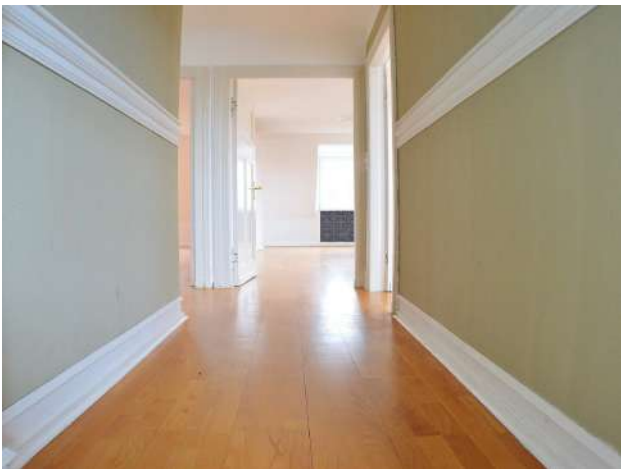
Hallway

Good Order, Clean

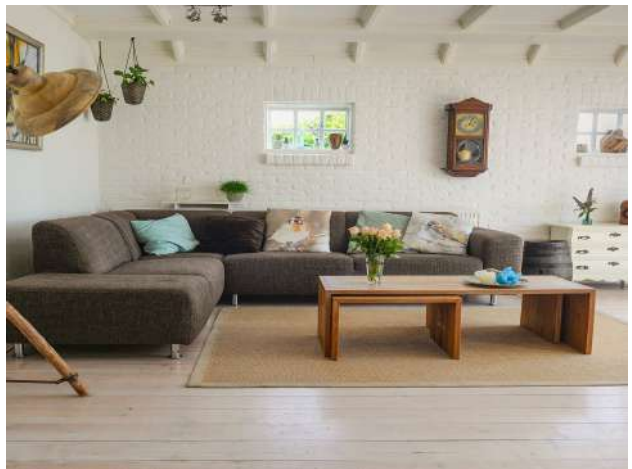
Lounge - Window panes blown Drip marks to right wall and slight warping to flooring from when the bedroom window was replaced during bad weather

Window panes blown Drip marks to right wall and slight warping to flooring from when the bedroom window was replaced during bad weather

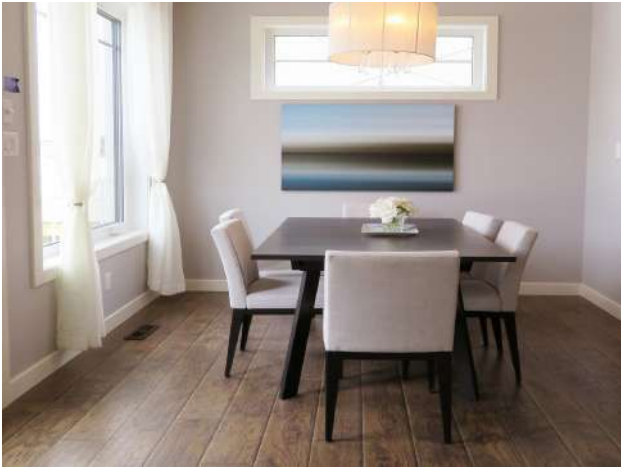
Dining Room

Good Order, Clean

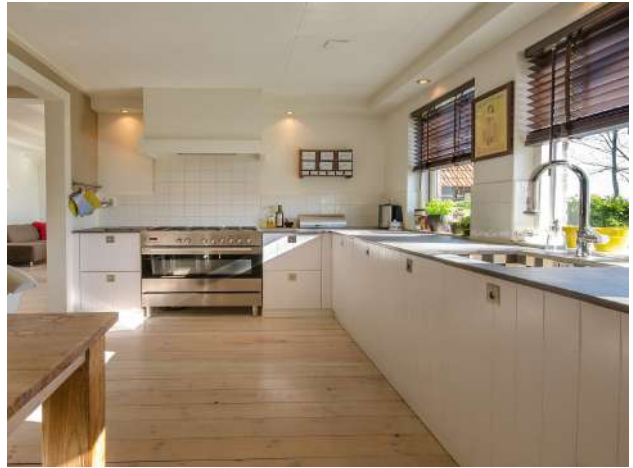
Kitchen - Front of hob chipped, tenant commented the builders who changed the window did this. Drip marks to walls around cooker from use of frying pan

Front of hob chipped, tenant commented the builders who changed the window did this. Drip marks to walls around cooker from use of frying pan

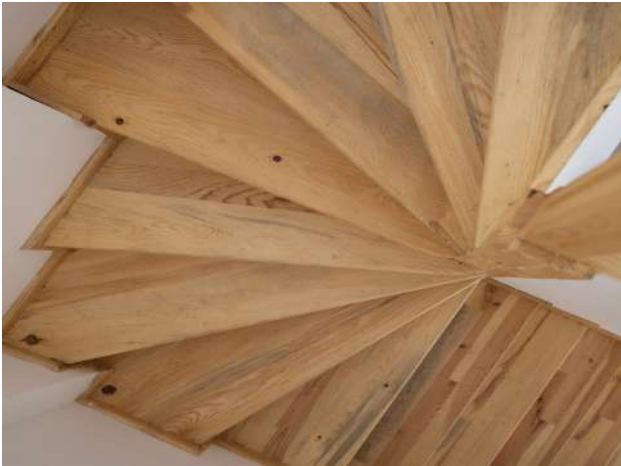
Stairs / Landing

Good Order, Clean

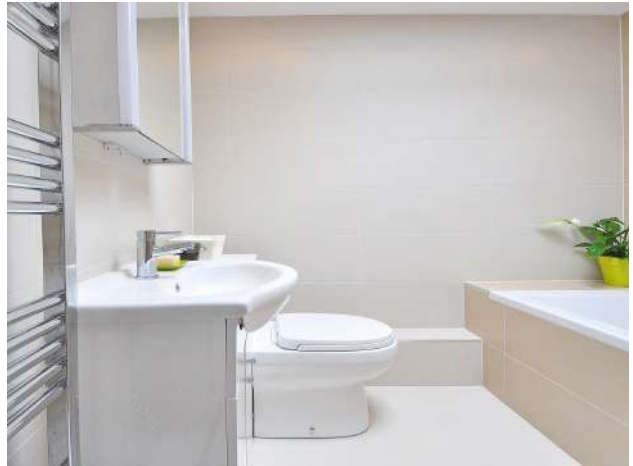
Bathroom(s)

Drip marks to wall around sink. 3 floor tiles cracked. Grouting missing in places. The tenant believes this is from the vibration of the washing machine/tumble dryer. Window surround rotting Window pane blown.

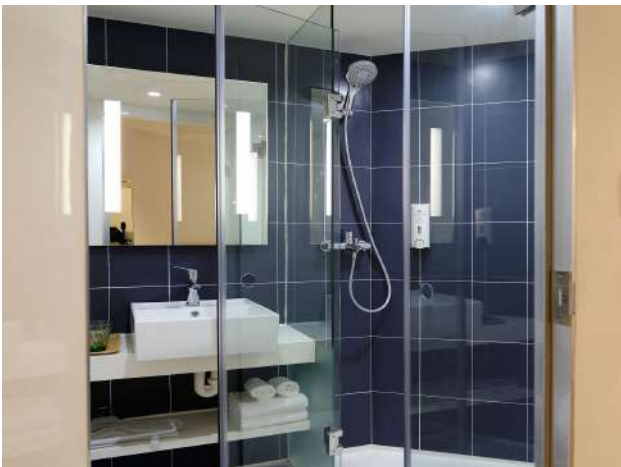
En Suite (s)

Good Order, Clean

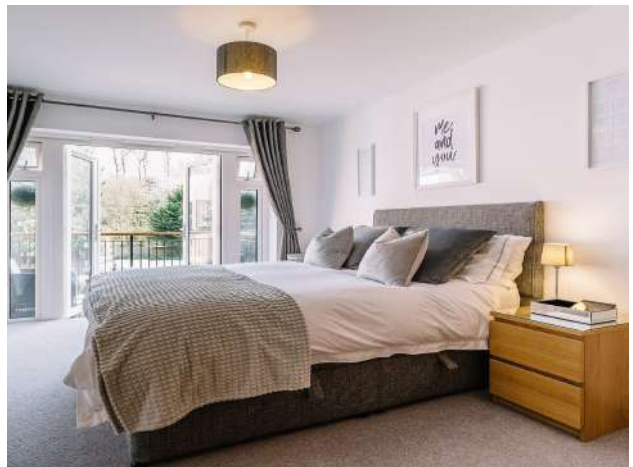
Bedroom 1

Paint peeling on ceiling, Clean

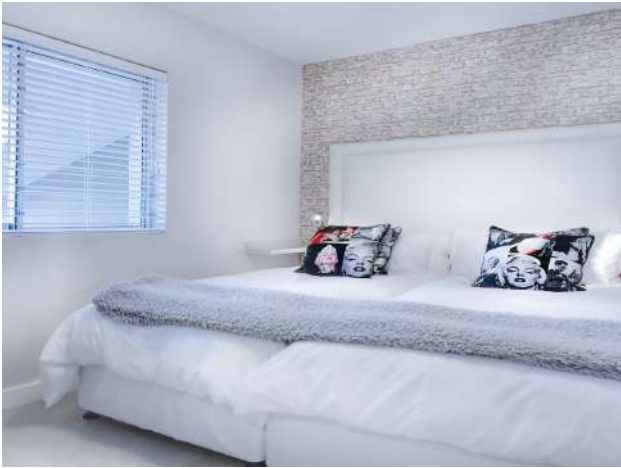
Bedroom 2

Drip marks and lining paper lifting to the right wall from when the window was replaced

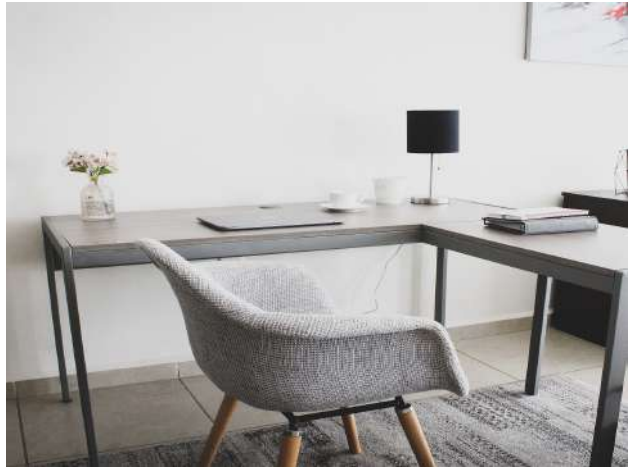
Bedroom 3

Being used as office, Good Order, Clean
